**Project: Southern Lehigh
School District –
Liberty Bell Elementary
School**

TRADE: Architectural

FIELD OBSERVATION REPORT

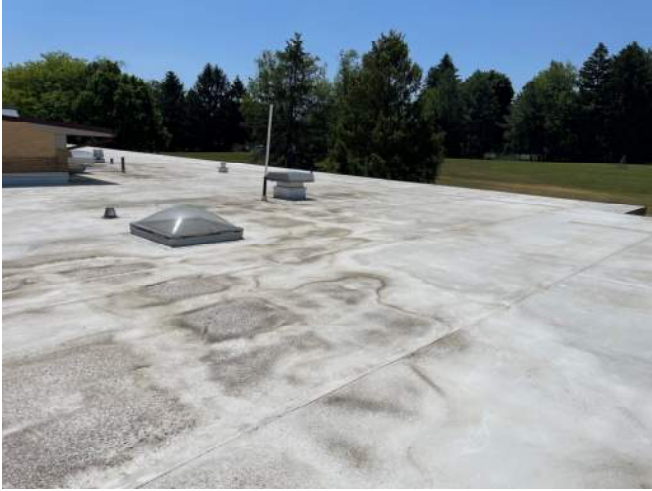
1.

- Current flat white TPO roof is currently out of warranty (per School District’s data).
- Most areas of the roof seem to be in good condition.
- Dried ponding residue (dirt / sediment) was observed in several locations on the roof and near the roof drains. (Figures #1, #5 & #10).

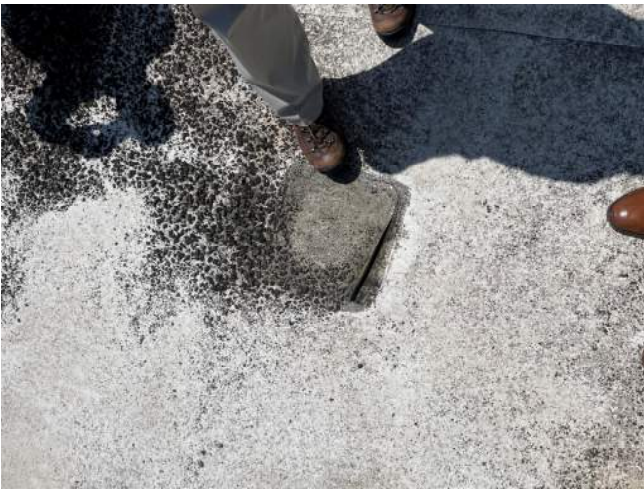
3.

- Several areas of minor roof patching / repair noticed (Figure #3).
- El Associates recommends a larger sampling of Indoor Air Quality (IAQ) Testing within the occupied spaces below to determine if the moisture saturated roofing system (per referenced report) is negatively impacting the occupied spaces below from an indoor air quality standpoint.

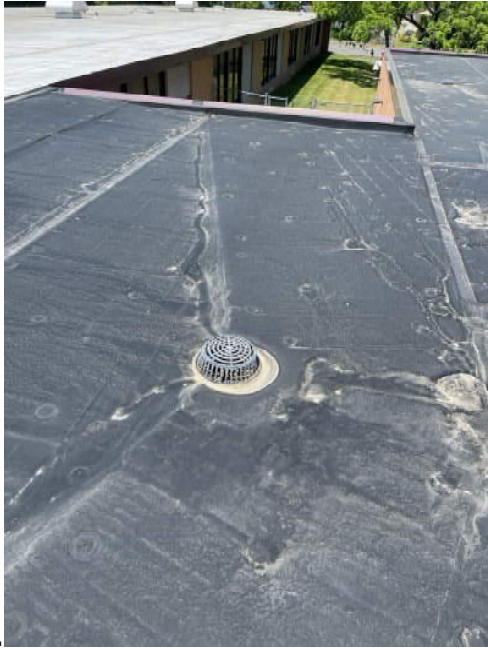
5.

- Several “soft spots” were noticed while walking the roof system, however these areas do not seem to be wide spread or create any concerns regarding the structural integrity of the roof system. (Figure #5).

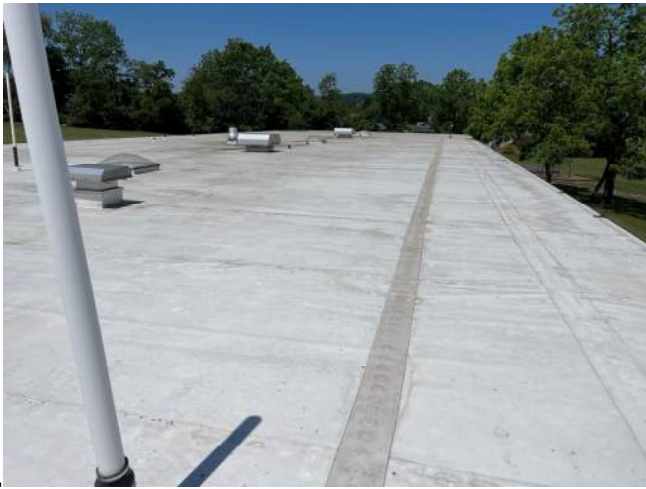
6.

- The quantity of roof drains (mostly aligned in center of roof, with no overflow drains) looks to be on the minimal side. We recommend water flow calculations be performed to confirm if the existing roof drains are adequate to handle the storm water flow from the roof surface. (Figure #6).
